# Manhole Inspection Summary

Manhole # S33CC2009MH

Insp Date: **12/20/06 9:48 AM**

**Location** Address: **5913 BRACKENRIDGE AVE** Cross Street: **BRACKENRIDGE CT**

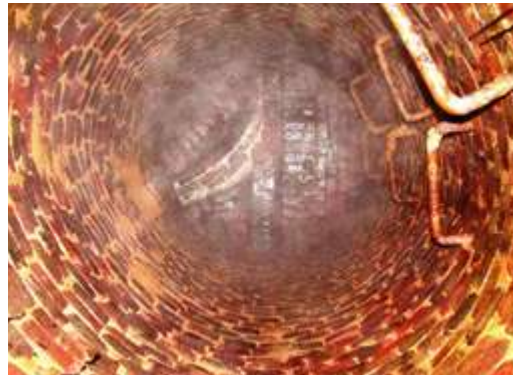
Top View

**Bench** ☒ Exists Material: **Brick** ☐ Parged ☒ **Debris** (not Condition related)  
Condition: ☒ Sound ☐ Cracked ☐ Root Intrusion ☐ Deteriorated ☐ Leaks ☐ Debris

**Steps** Count: **7** Missing: **0** ☒ **Corroded**

Corroded steps. Bench debris.

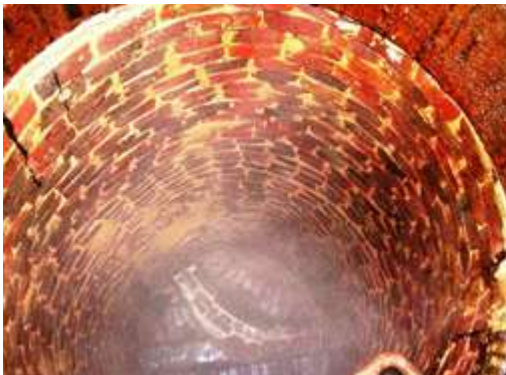
Defect

**Frame** Offset: **0** (in.) Condition: ☐ Sound ☐ Cracked ☒ **Leaks**

Frame leaks. Adjustment, Corbel and Barrel infiltration - other side.

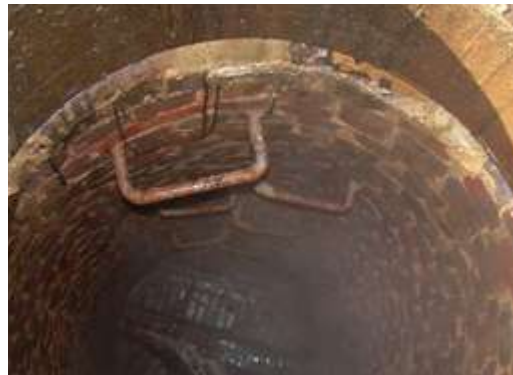
Defect

**Chimney / Frame Adjustment** ☒ Exists Material: **Brick** ☐ Parged Height: **5** (in.)  
Condition: ☐ Sound ☐ Cracked ☐ Root Intrusion ☐ Loose Brick ☒ **Deteriorated**  
Infiltration: ☐ None ☒ **Joint** ☐ Cracks ☒ **Mortar** ☐ Roots ☐ Wall

**Corbel** Material: **Brick** ☐ Parged Type: **Concentric/Eccentric**  
Condition: ☒ Sound ☐ Cracked ☐ Root Intrusion ☐ Loose Brick ☐ Deteriorated  
Infiltration: ☐ None ☐ Joint ☐ Cracks ☒ **Mortar** ☐ Roots ☒ **Wall**

**Barrel** Material: **Brick** ☐ Parged  
Shape: **Circular** Diameter: **42** (in.) Length: (in.)  
Condition: ☒ Sound ☐ Cracked ☐ Root Intrusion ☐ Loose Brick ☐ Deteriorated  
Infiltration: ☐ None ☐ Joint ☐ Cracks ☒ **Mortar** ☐ Roots ☒ **Wall**

Frame leaks. Adjustment deterioration and infiltration. Corbel and Barrel infiltration.

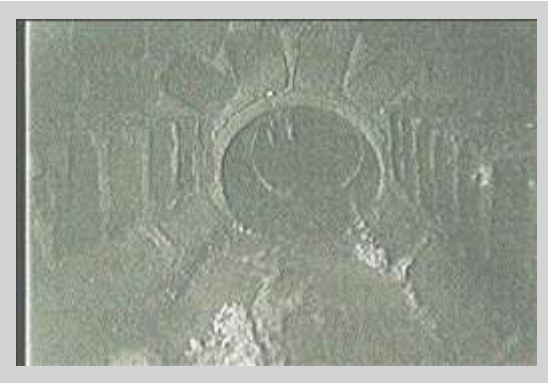
### 8 in. Circular Gravity Sewer Pipe Out @ 12 O'Clock

**Channel** Material: **Brick** ☐ Parged ☐ Debris (not Condition related)  
Channel Exposure: **Fully Open** Junc Dist: **0** nearest .5 ft. Azimuth:  
Condition: ☐ Sound ☐ Cracked ☐ Root Intrusion ☒ **Deteriorated** ☐ Leaks ☐ Debris

Channel deterioration.

Deposits: ☐ None ☐ Mud ☐ Sludge ☒ Debris ☒ Grease

Silt Depth: **1** (in.) Deposits Extent: **Light**

Infiltration: **Evidence** Pipe Seal Cond: **Cracked**

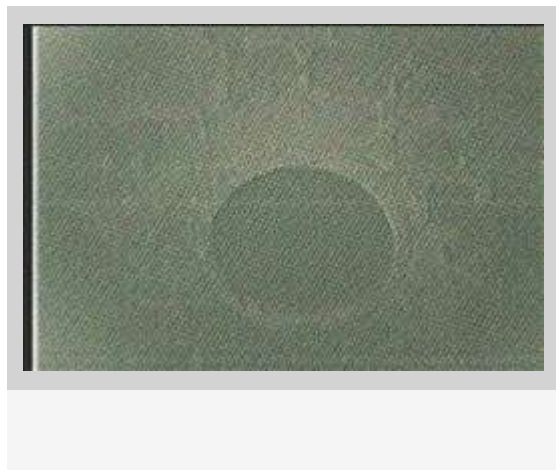
Pipe In @ 8 O'Clock

Infiltration: **Evidence**

Drop: **Outside** Rod and Bar

Drop Condition: **Open**
